**PHASE I ENVIRONMENTAL
SITE ASSESSMENT
DENTAL-ONE BUILDING
2205 CORPORATE PLAZA PARKWAY
COBB COUNTY, GEORGIA**

SEA JOB #972-152

RE: Phase I Environmental Site
Assessment
Dental - One Building
2205 Corporate Plaza Parkway
Cobb County, Georgia
SEA Job #972-152

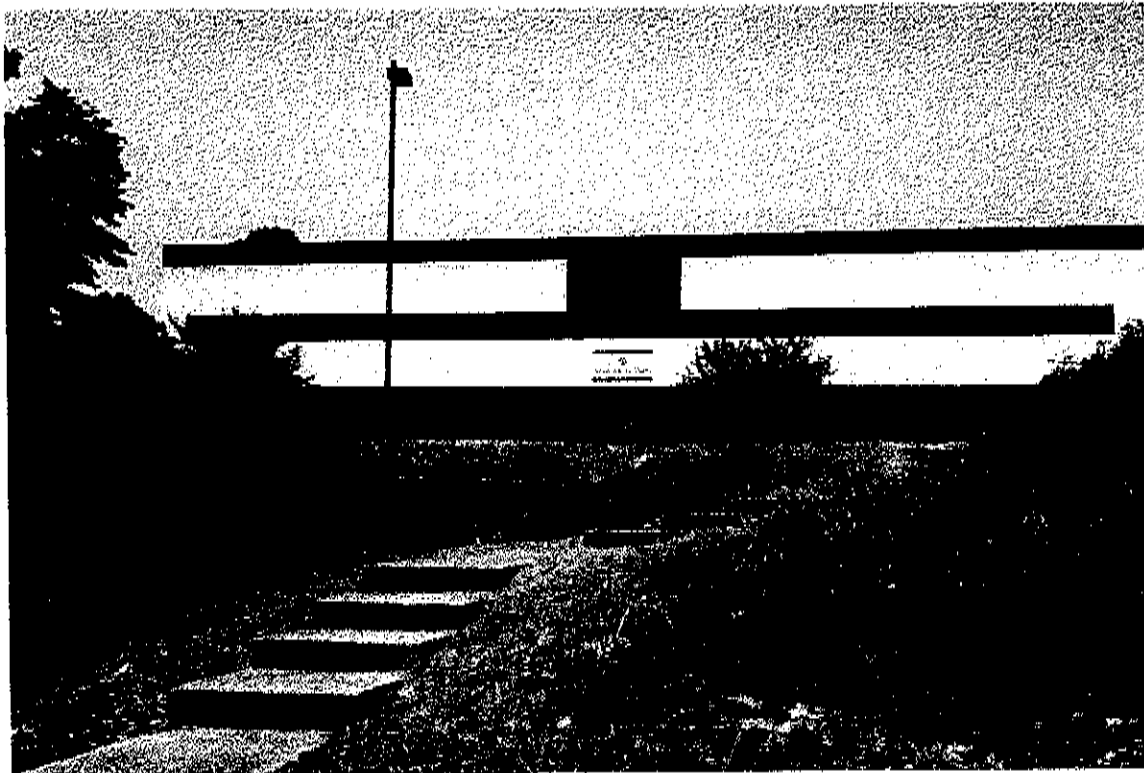
VIEW OF THE SUBJECT BUILDING FACING WEST
