**PHASE I ENVIRONMENTAL  
SITE ASSESSMENT  
DENTAL-ONE BUILDING  
2205 CORPORATE PLAZA PARKWAY  
COBB COUNTY, GEORGIA**

**SEA JOB #972-152**

RE: Phase I Environmental Site  
Assessment  
Dental - One Building  
2205 Corporate Plaza Parkway  
Cobb County, Georgia  
SEA Job #972-152

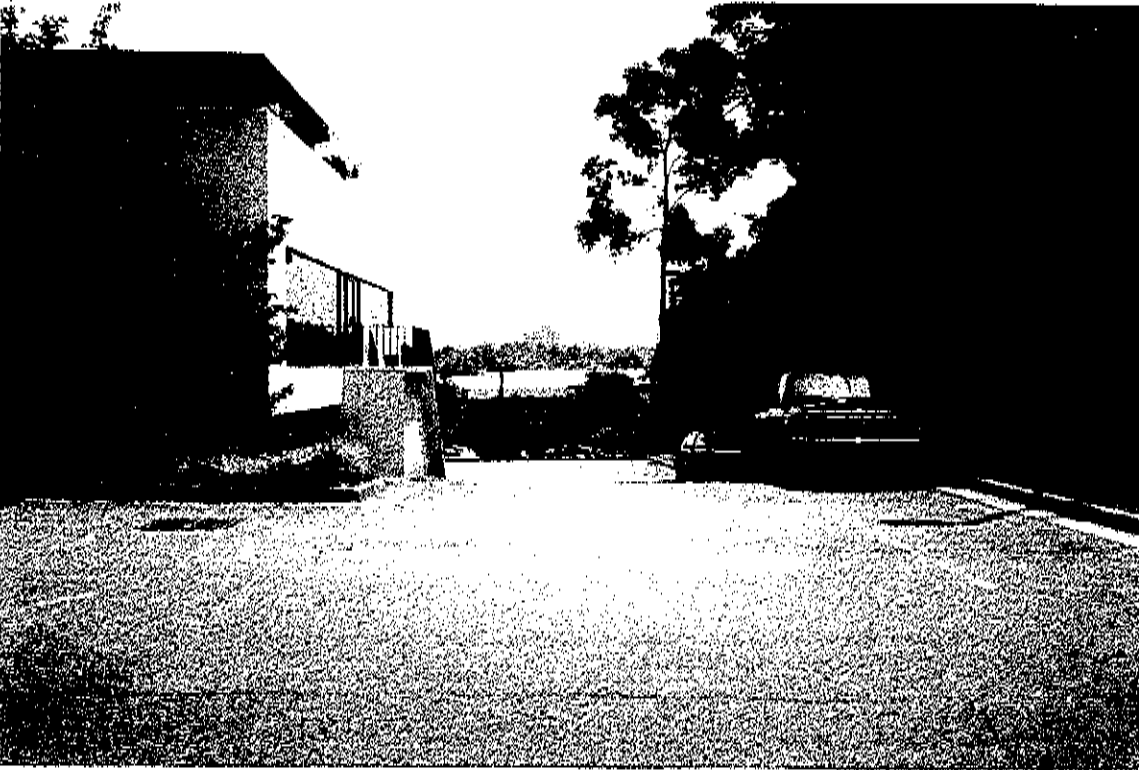
**VIEW ALONG THE SOUTHERN PROPERTY BOUNDARY**

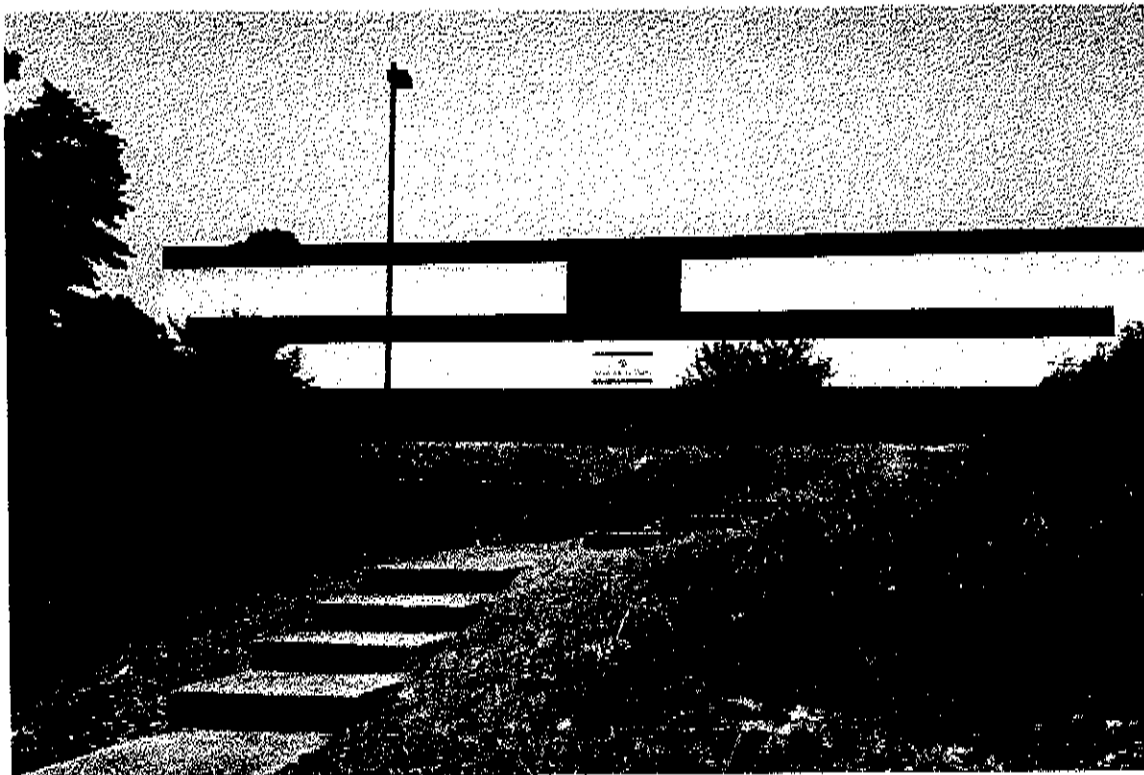
VIEW OF THE SUBJECT BUILDING FACING WEST
